**Flood Control Project Maintenance
Levee Inspections****LMA District Cover Sheet****Spring 2011 Levee Inspection Results****Reclamation District No. 0785 Driver**

Spring 2011 Levee Inspection Results

Reclamation District No. 0785 Driver

Waterway			Bank	Unit Miles
Unit No. 01 Sacramento River			Right	2.31

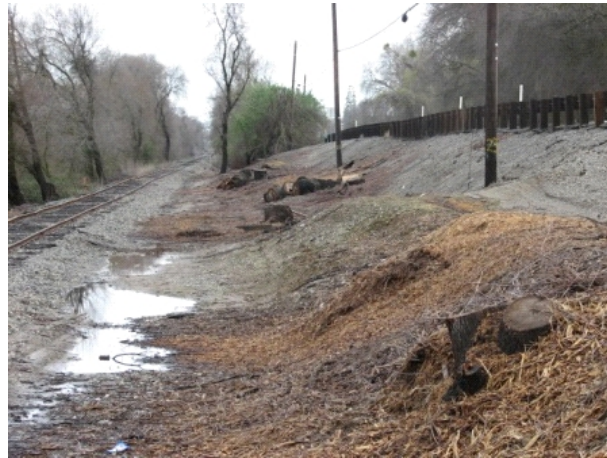
Levee Mile Report Line	1
Start Levee Mile	0.13
End Levee Mile	1.36
Location	Land Side
Category	Earthen Levee
Item	Trim / Thin Trees
The trees were cut by PG&E'S tree contractor. The district will take care of the stumps in the future.	
johnngw_s_20110316_388.jpg

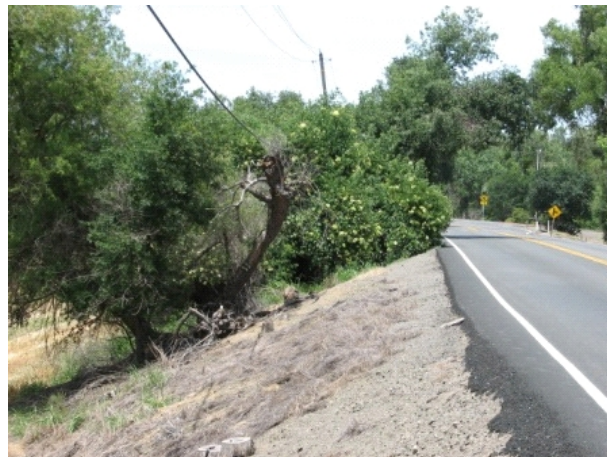
Levee Mile Report Line	2
Start Levee Mile	0.29
End Levee Mile	0.29
Location	Land Side
Category	Earthen Levee
Item	Vegetation
Elderberry	
johnngw_s_20110228_202.jpg

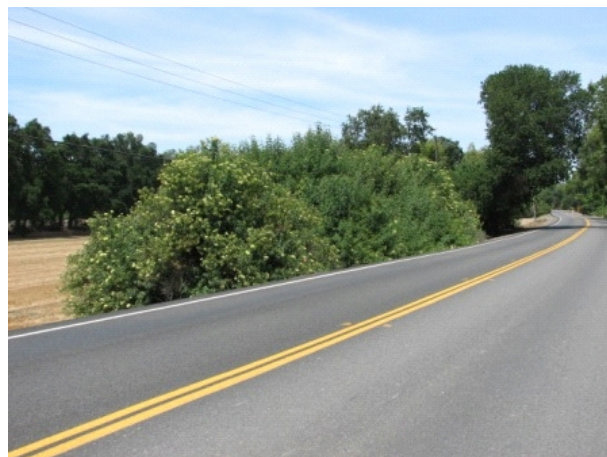
Levee Mile Report Line	3
Start Levee Mile	0.41
End Levee Mile	0.45
Location	Land Side
Category	Earthen Levee
Item	Vegetation
Elderberry	
johnngw_s_20110228_203.jpg

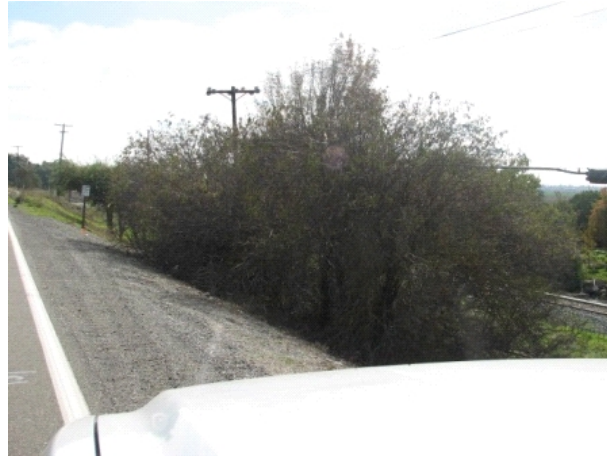
Levee Mile Report Line	5
Start Levee Mile	1.32
End Levee Mile	1.32
Location	Land Side
Category	Earthen Levee
Item	Vegetation
This is a very large Elderberry bush	
johngw_s_20110228_204.jpg

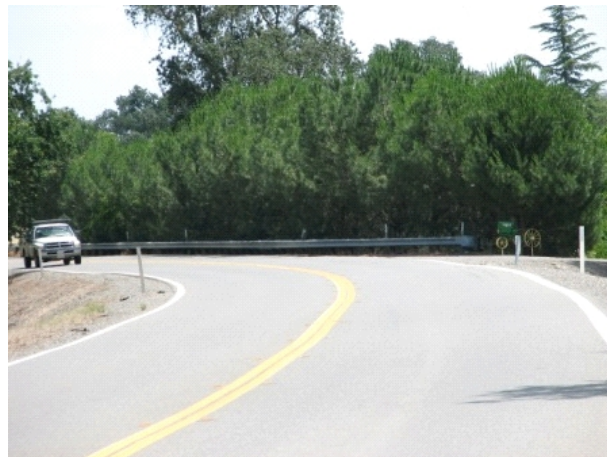
Levee Mile Report Line	7
Start Levee Mile	2.04
End Levee Mile	2.14
Location	Land Side
Category	Earthen Levee
Item	Encroachments
pines and oleanders along shoulder	
johngw_s_20110228_205.jpg

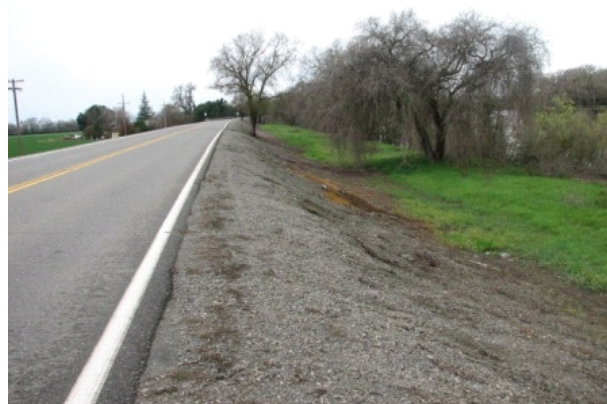
Levee Mile Report Line	8
Start Levee Mile	2.23
End Levee Mile	2.23
Location	Water Side
Category	Earthen Levee
Item	Vegetation
The district sprays the slopes for vegetation control.	
johngw_s_20110316_389.jpg

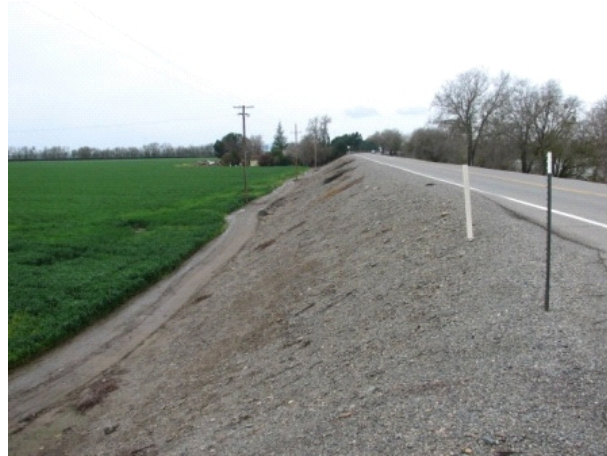
Levee Mile Report Line	9
Start Levee Mile	2.23
End Levee Mile	2.23
Location	Land Side
Category	Earthen Levee
Item	Vegetation
The landside slope is sprayed for vegetation control.	
johngw_s_20110316_390.jpg

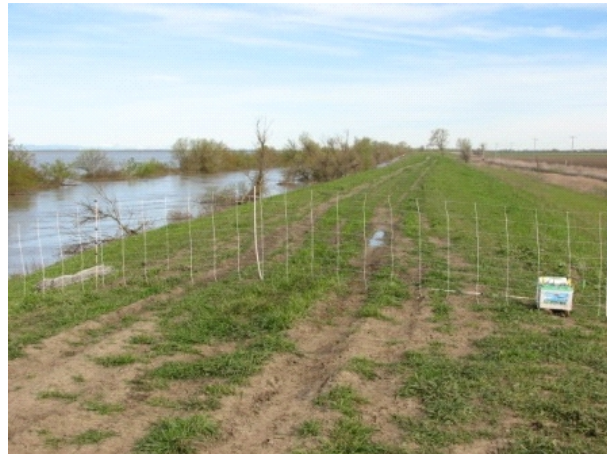
Levee Mile Report Line	8
Start Levee Mile	1.50
End Levee Mile	1.50
Location	Crown
Category	Earthen Levee
Item	Crown Surface / Depressions / Rutting

The crown of the levee with vegetation on the roadway. There is some depressions on the crown from vehicle use.
